REPORT

Handläggare, enhet / <i>Handled by, department</i>	Datum / <i>Date</i>	Beteckning / <i>Reference</i>	Sida / <i>Page</i>
Jukka Holappa, Building Technology and Mechanics +46 33 16 50 65, jukka.holappa@sp.se	2003-03-24	BMh P301619	1 (3)

Tensile strength test on eyelets.

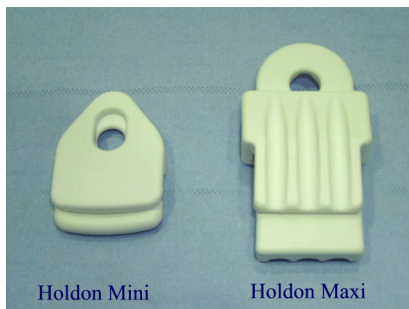
Photo 1

Holdon Mini and Maxi clip-on eyelets see photo 1. Round brass-eyelets and plastic-eyelets see photo 2. The holding efficiency is tested on 650/700 coated vinyl fabrics.

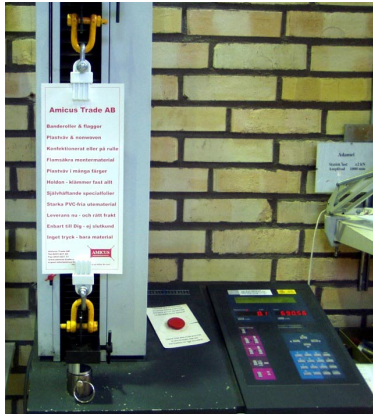
Holdon Mini and Maxi clip-on eyelets were tested on coated vinyl fabrics to see the holding efficiency. Through the round brass-eyelets and plastic-eyelets there were mounted suitable axles. The test objects were mounted in the testing machine called Adamel see photo 3. The test objects were then pulled to fracture with a constant speed of 20 mm/min.

Photo 3. Adamel testing machine with Holdon Maxi.
